Trout creek June 2008

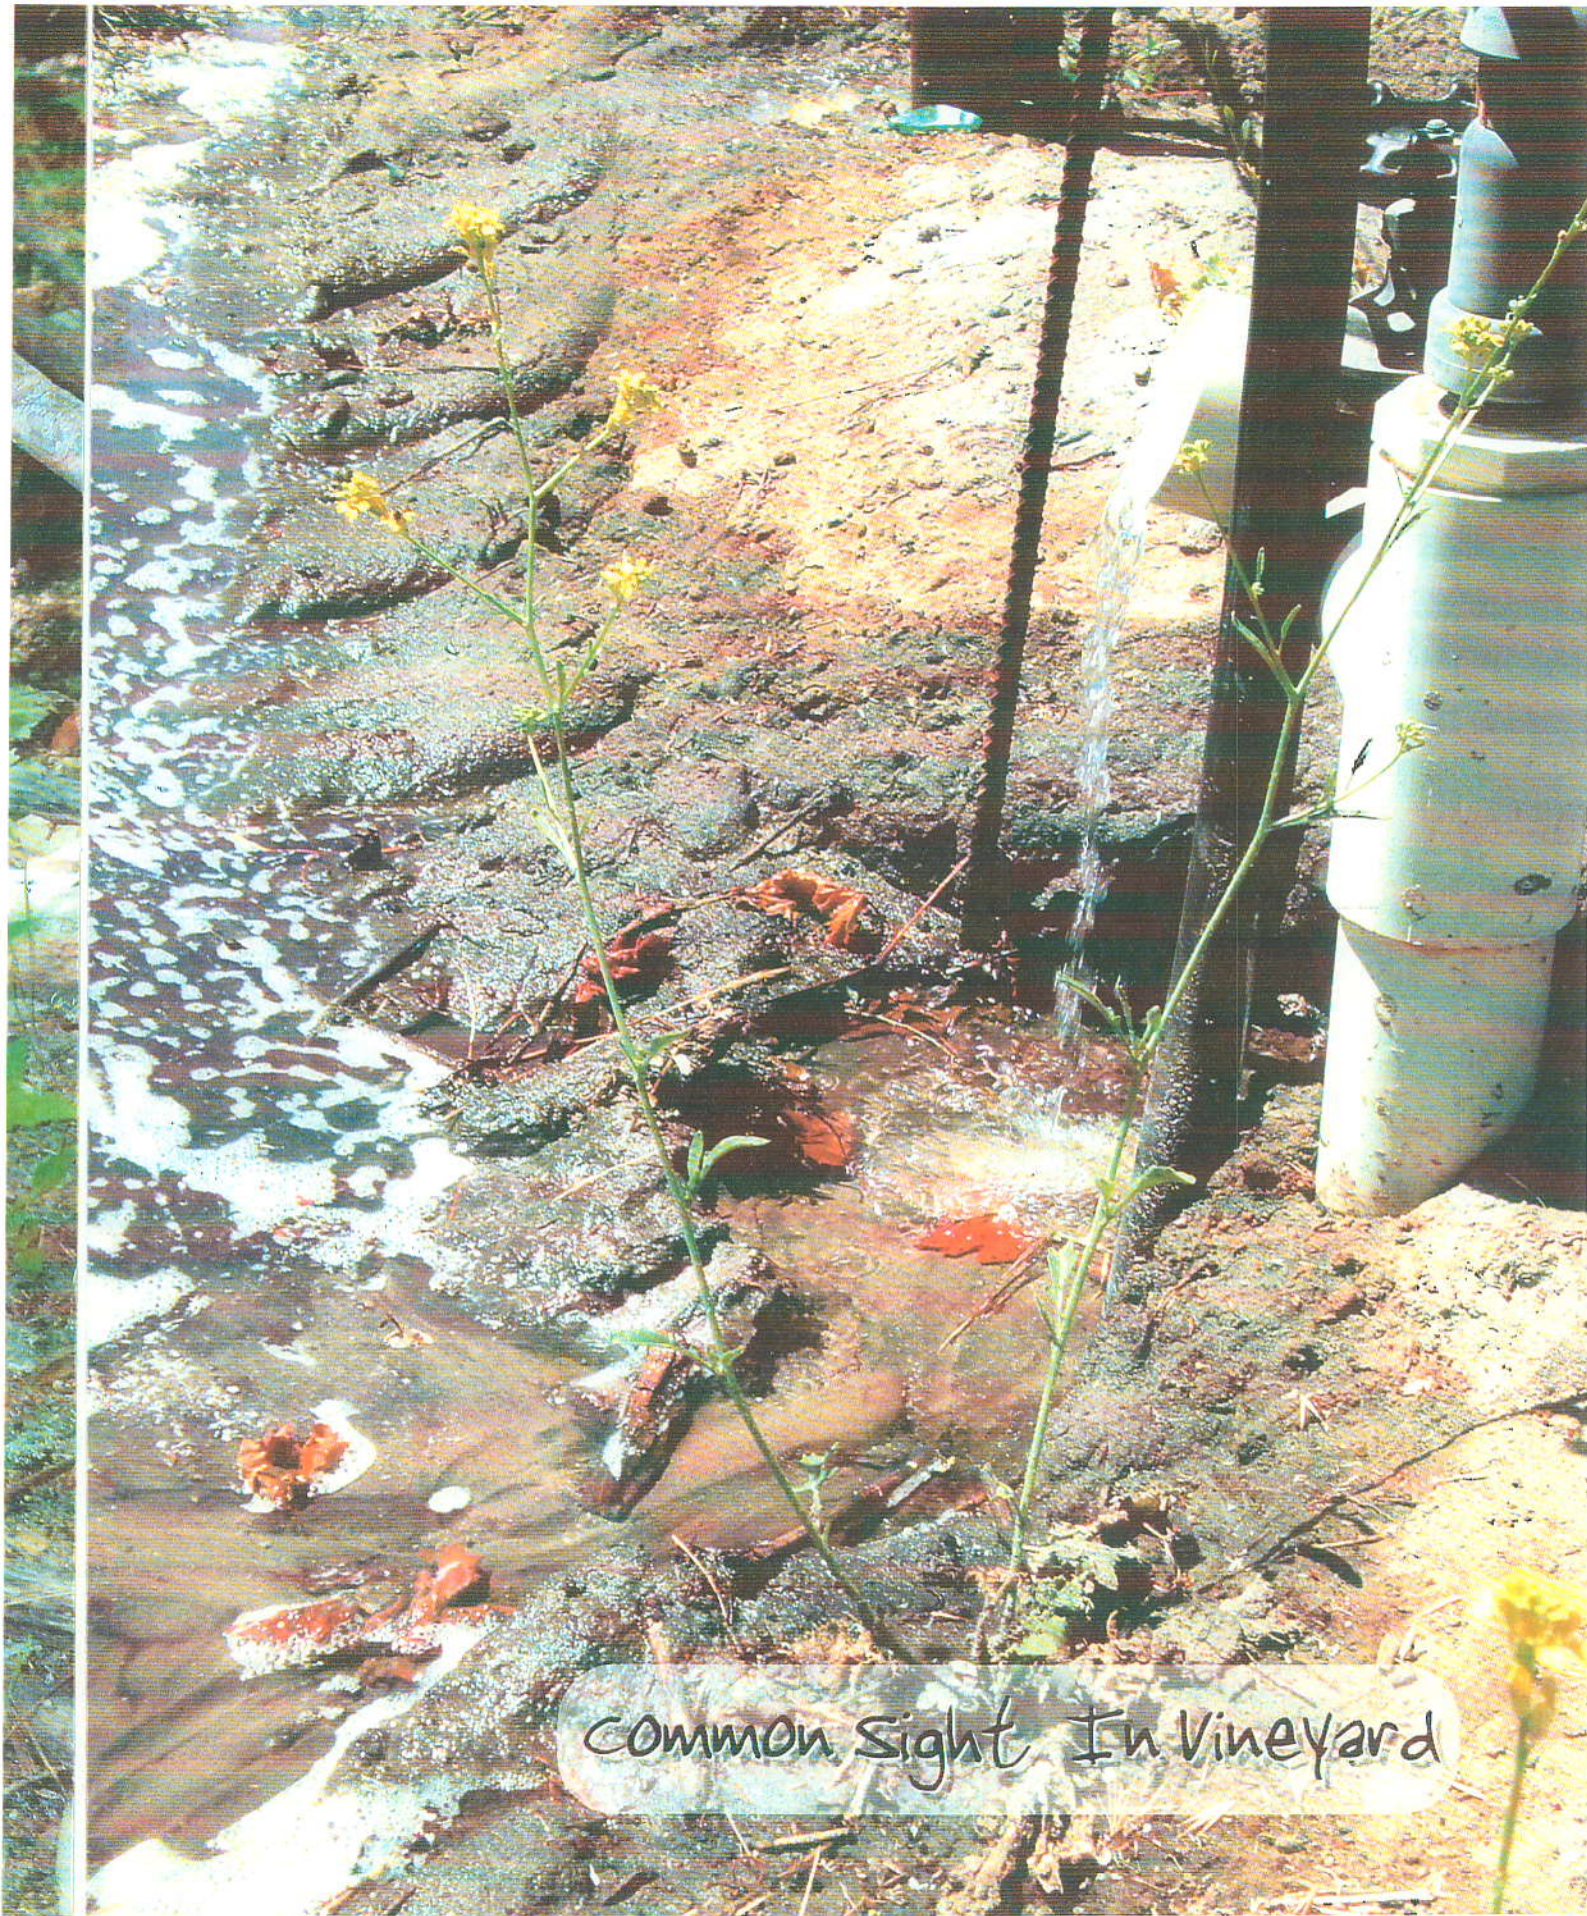
common sight In Vineyard

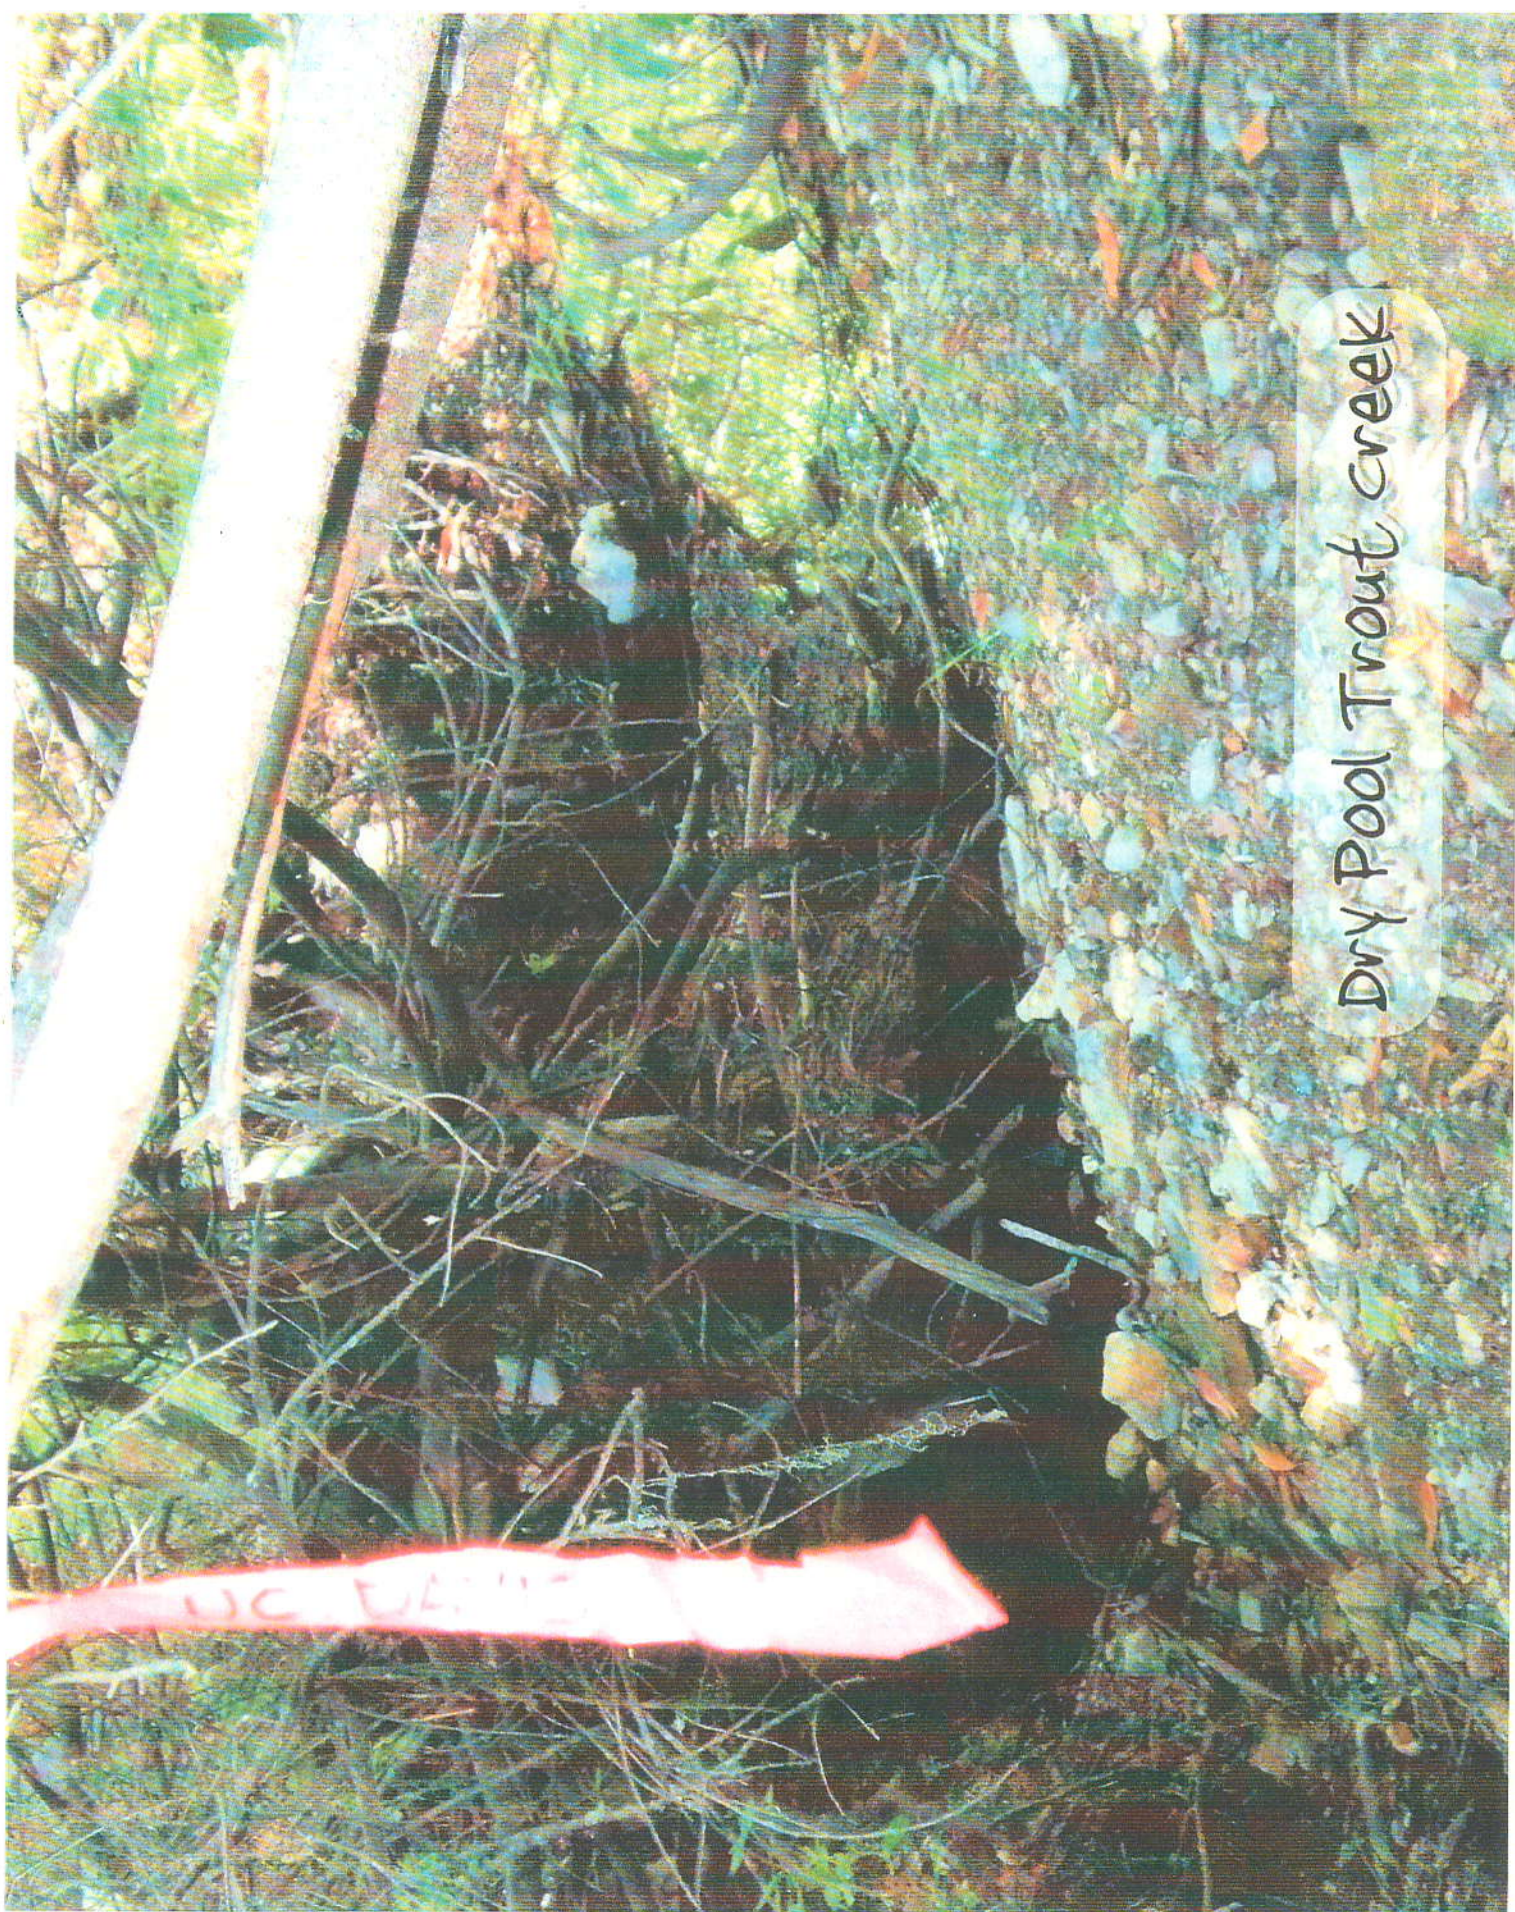
Dry Pool Trout creek

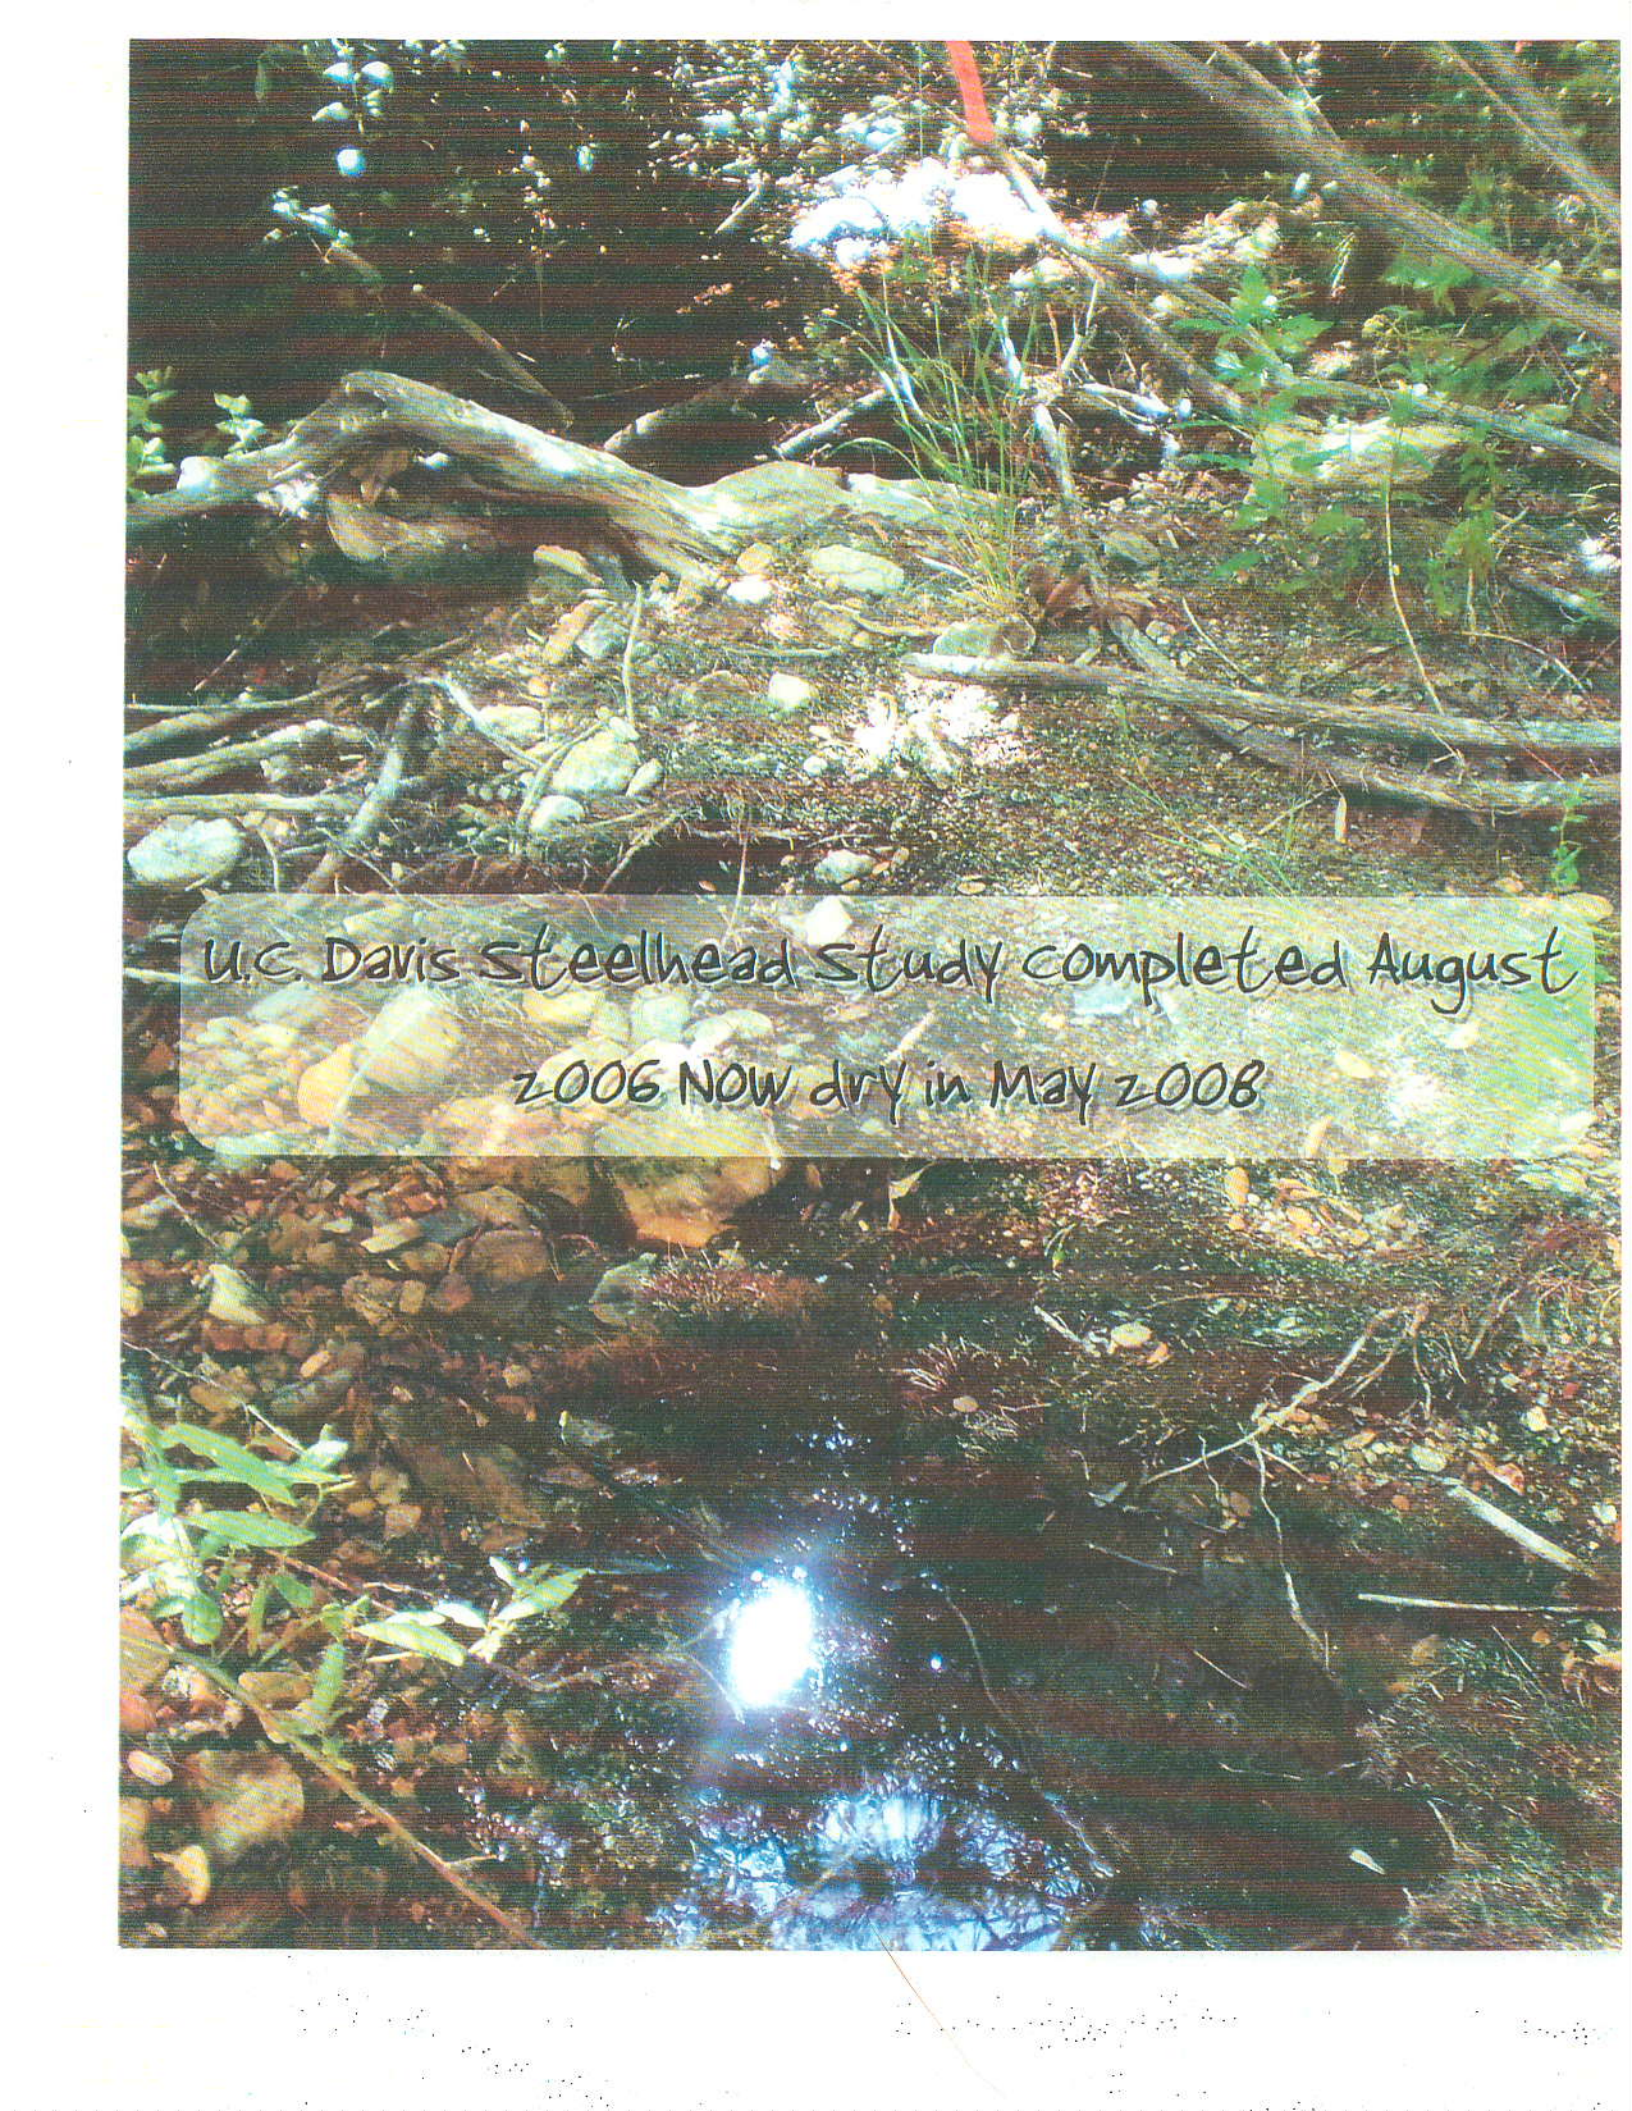
U.C. Davis Steelhead Study completed August  
2006 NOW dry in May 2008

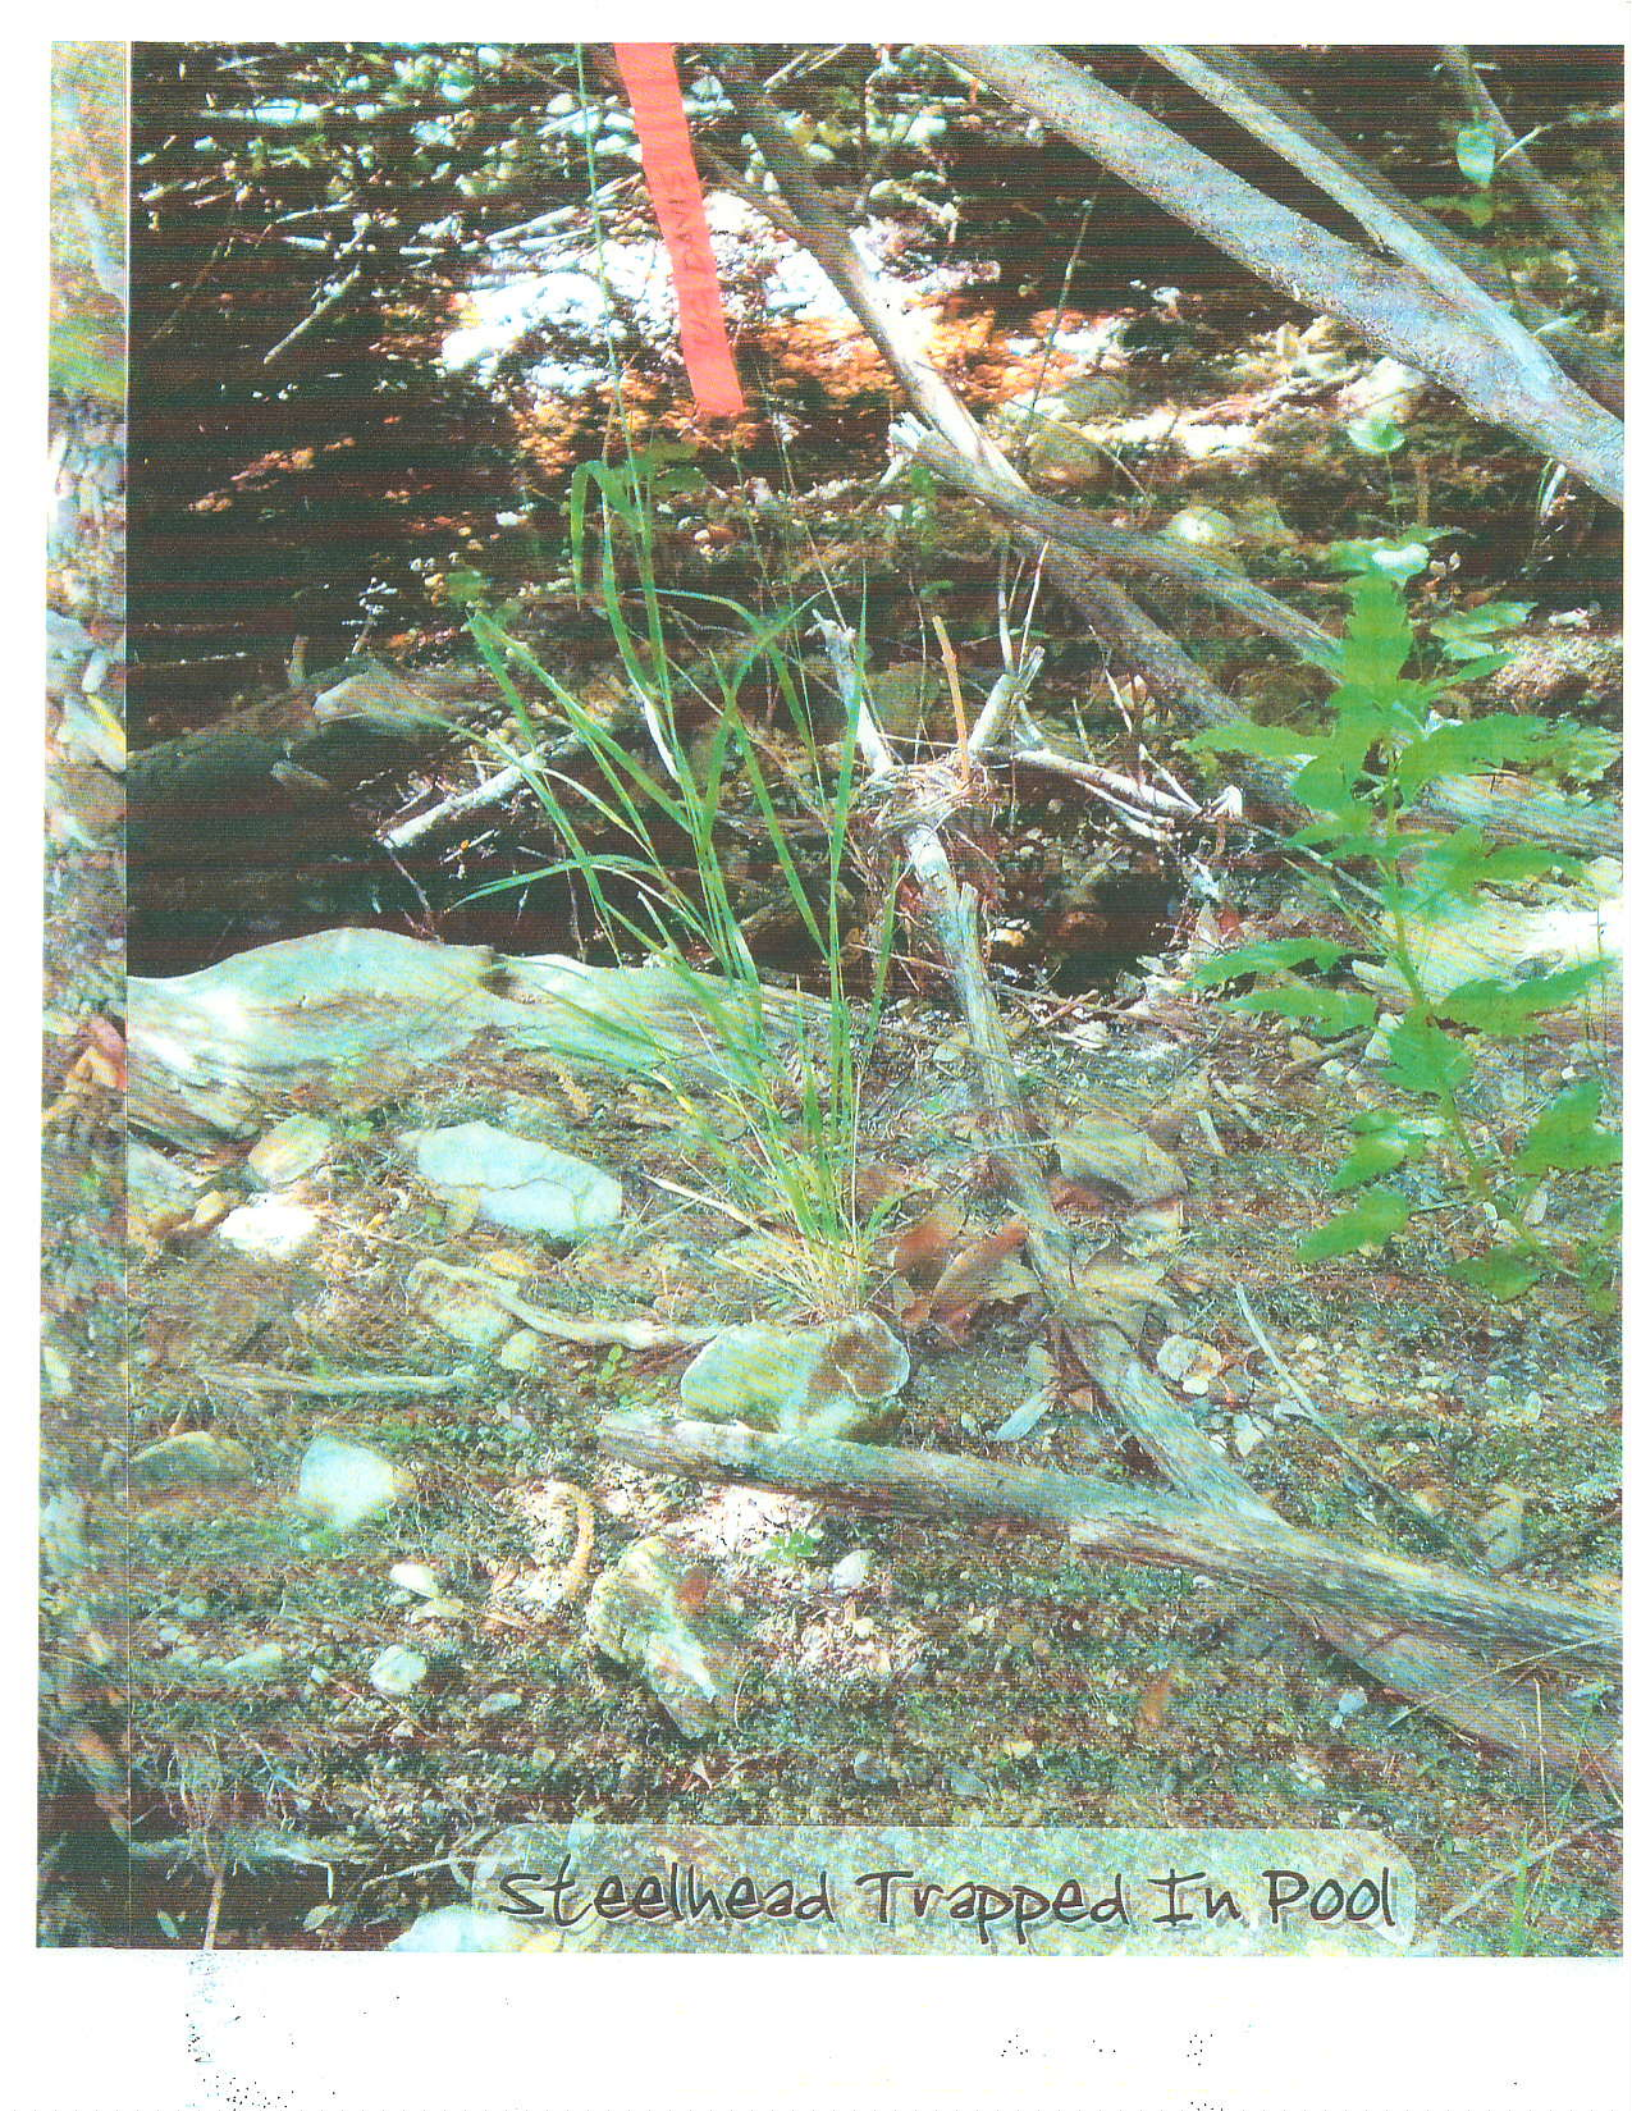
Steelhead Trapped In Pool

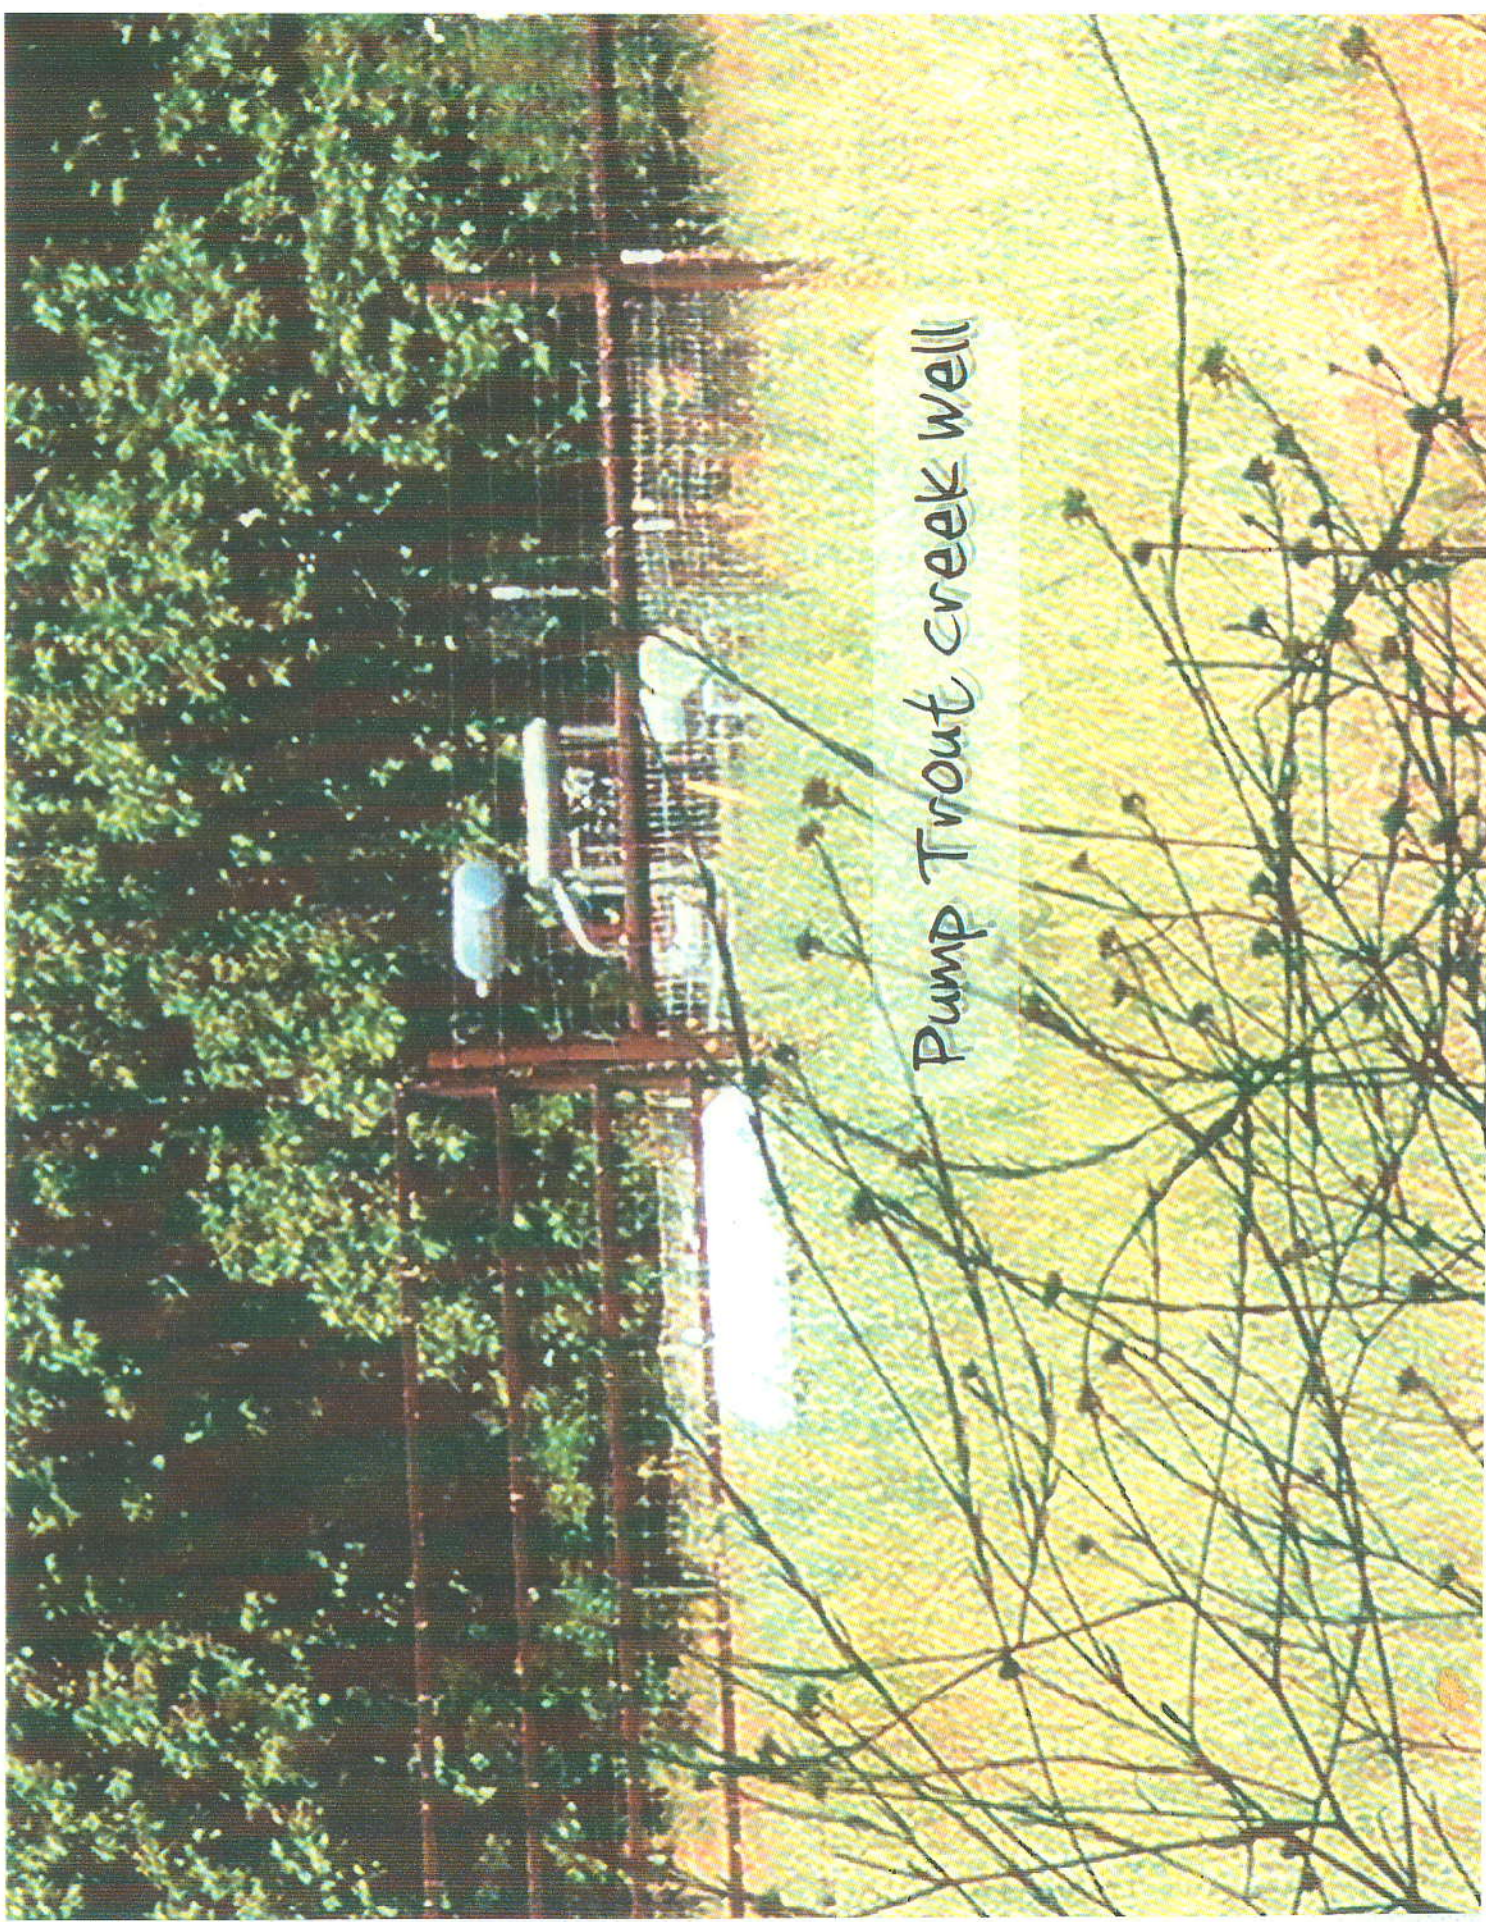
Pump Trout creek well

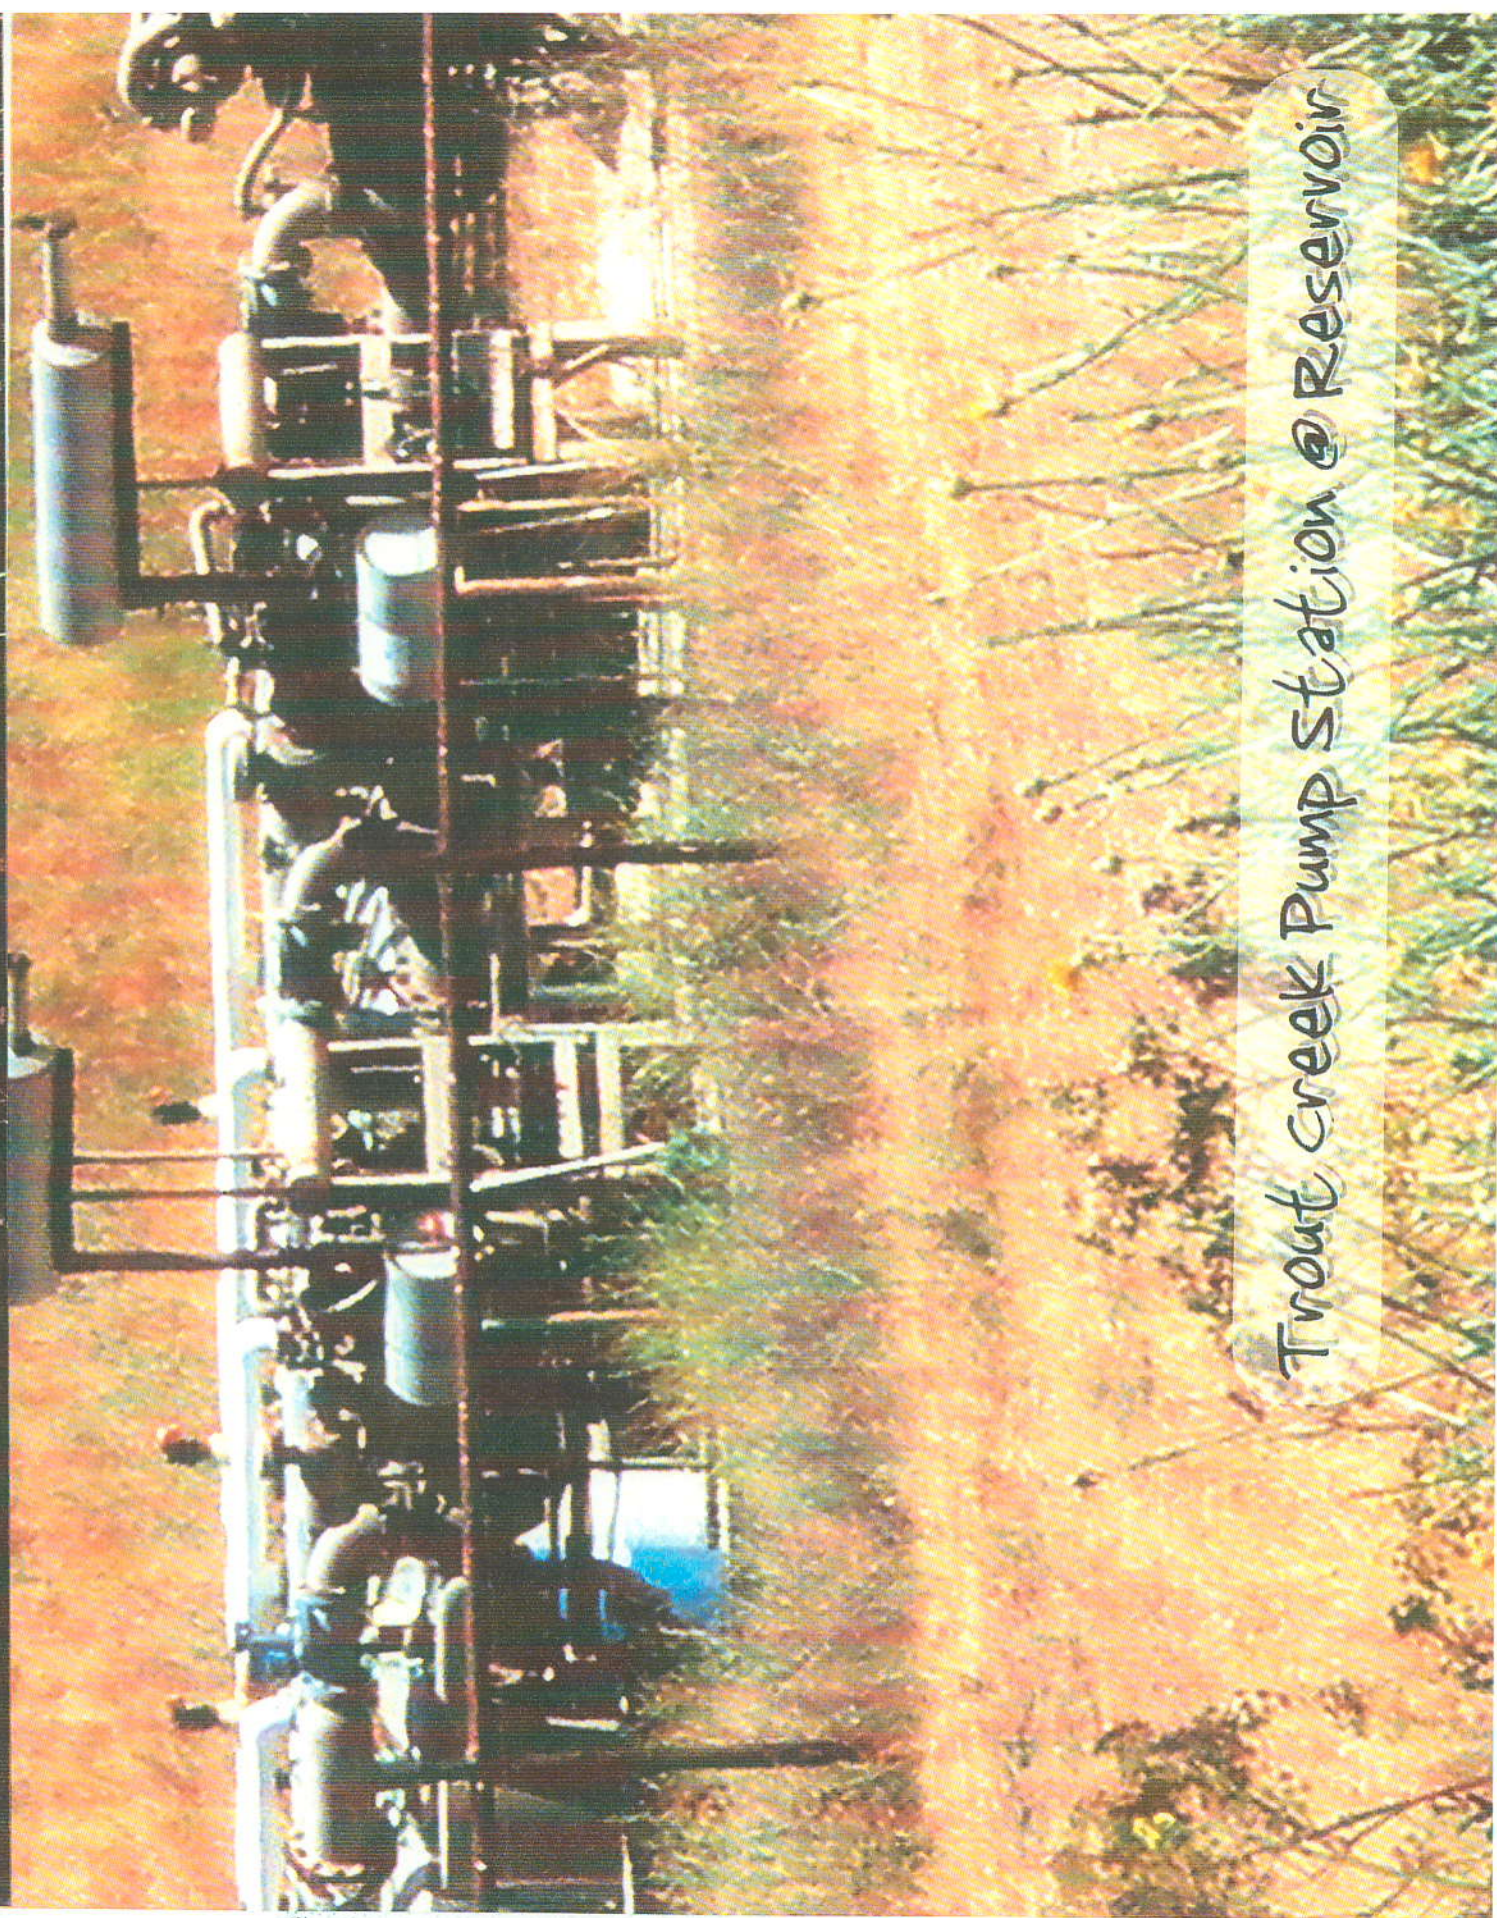
Trout Creek Pump Station @ Reservoir

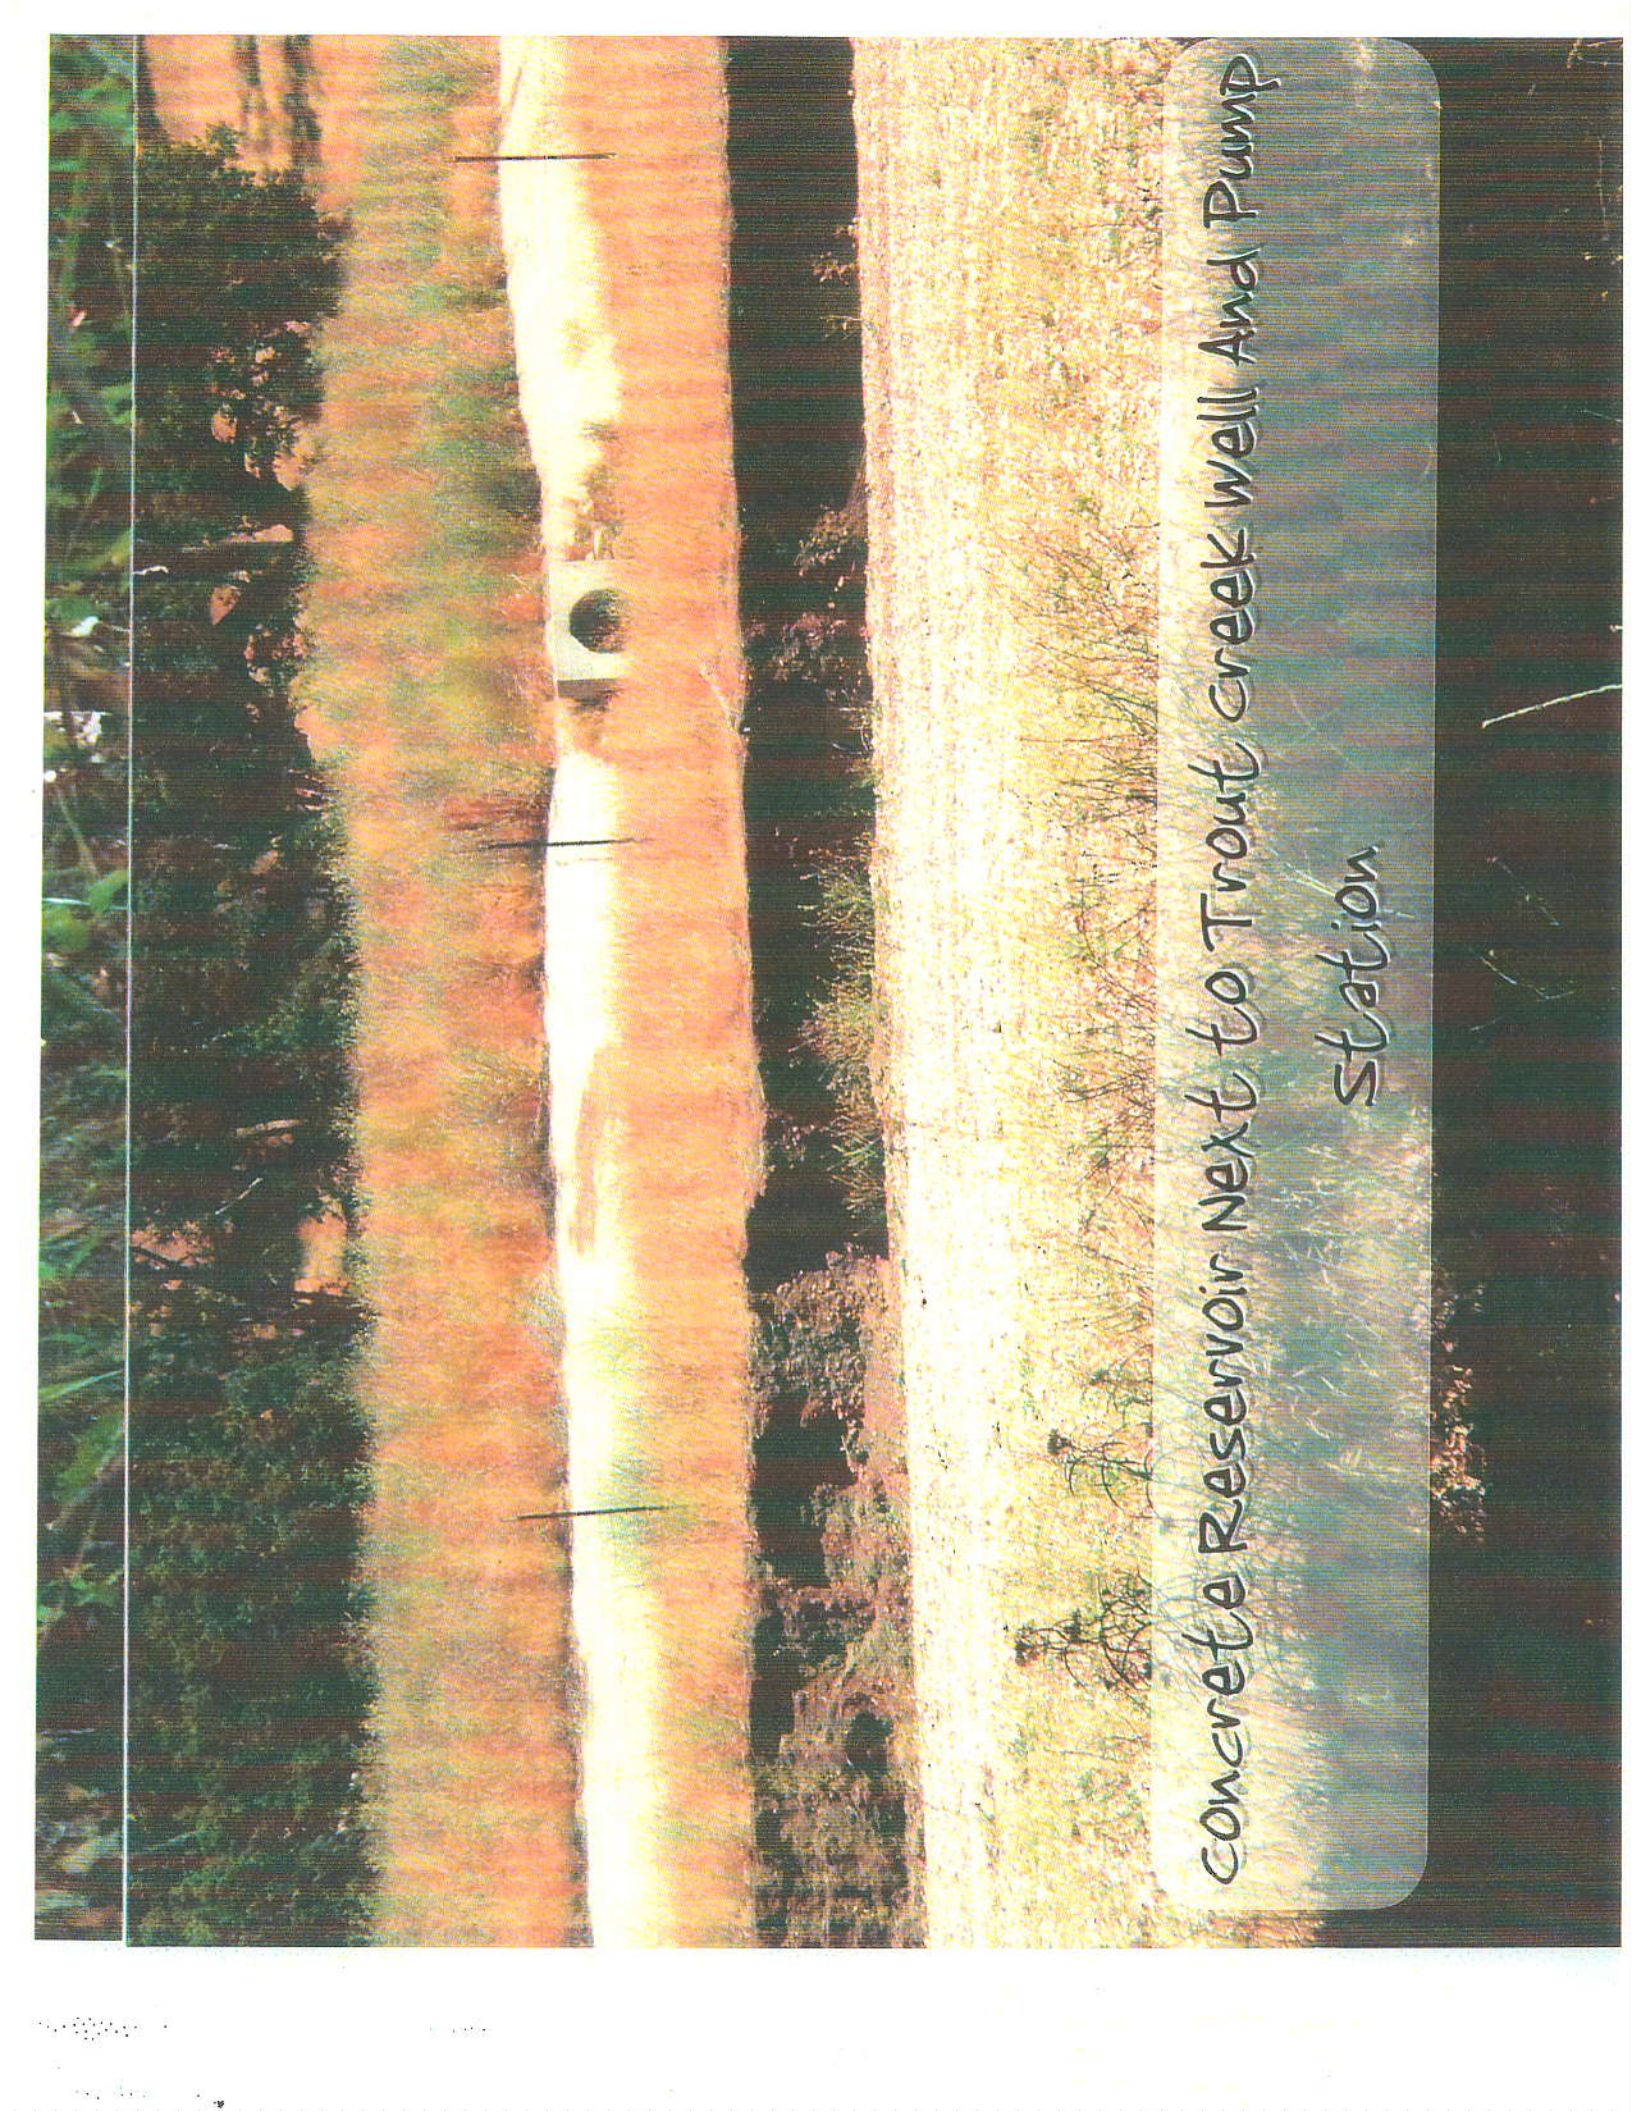
Trout Creek Dewatered
