Trout creek June 2008

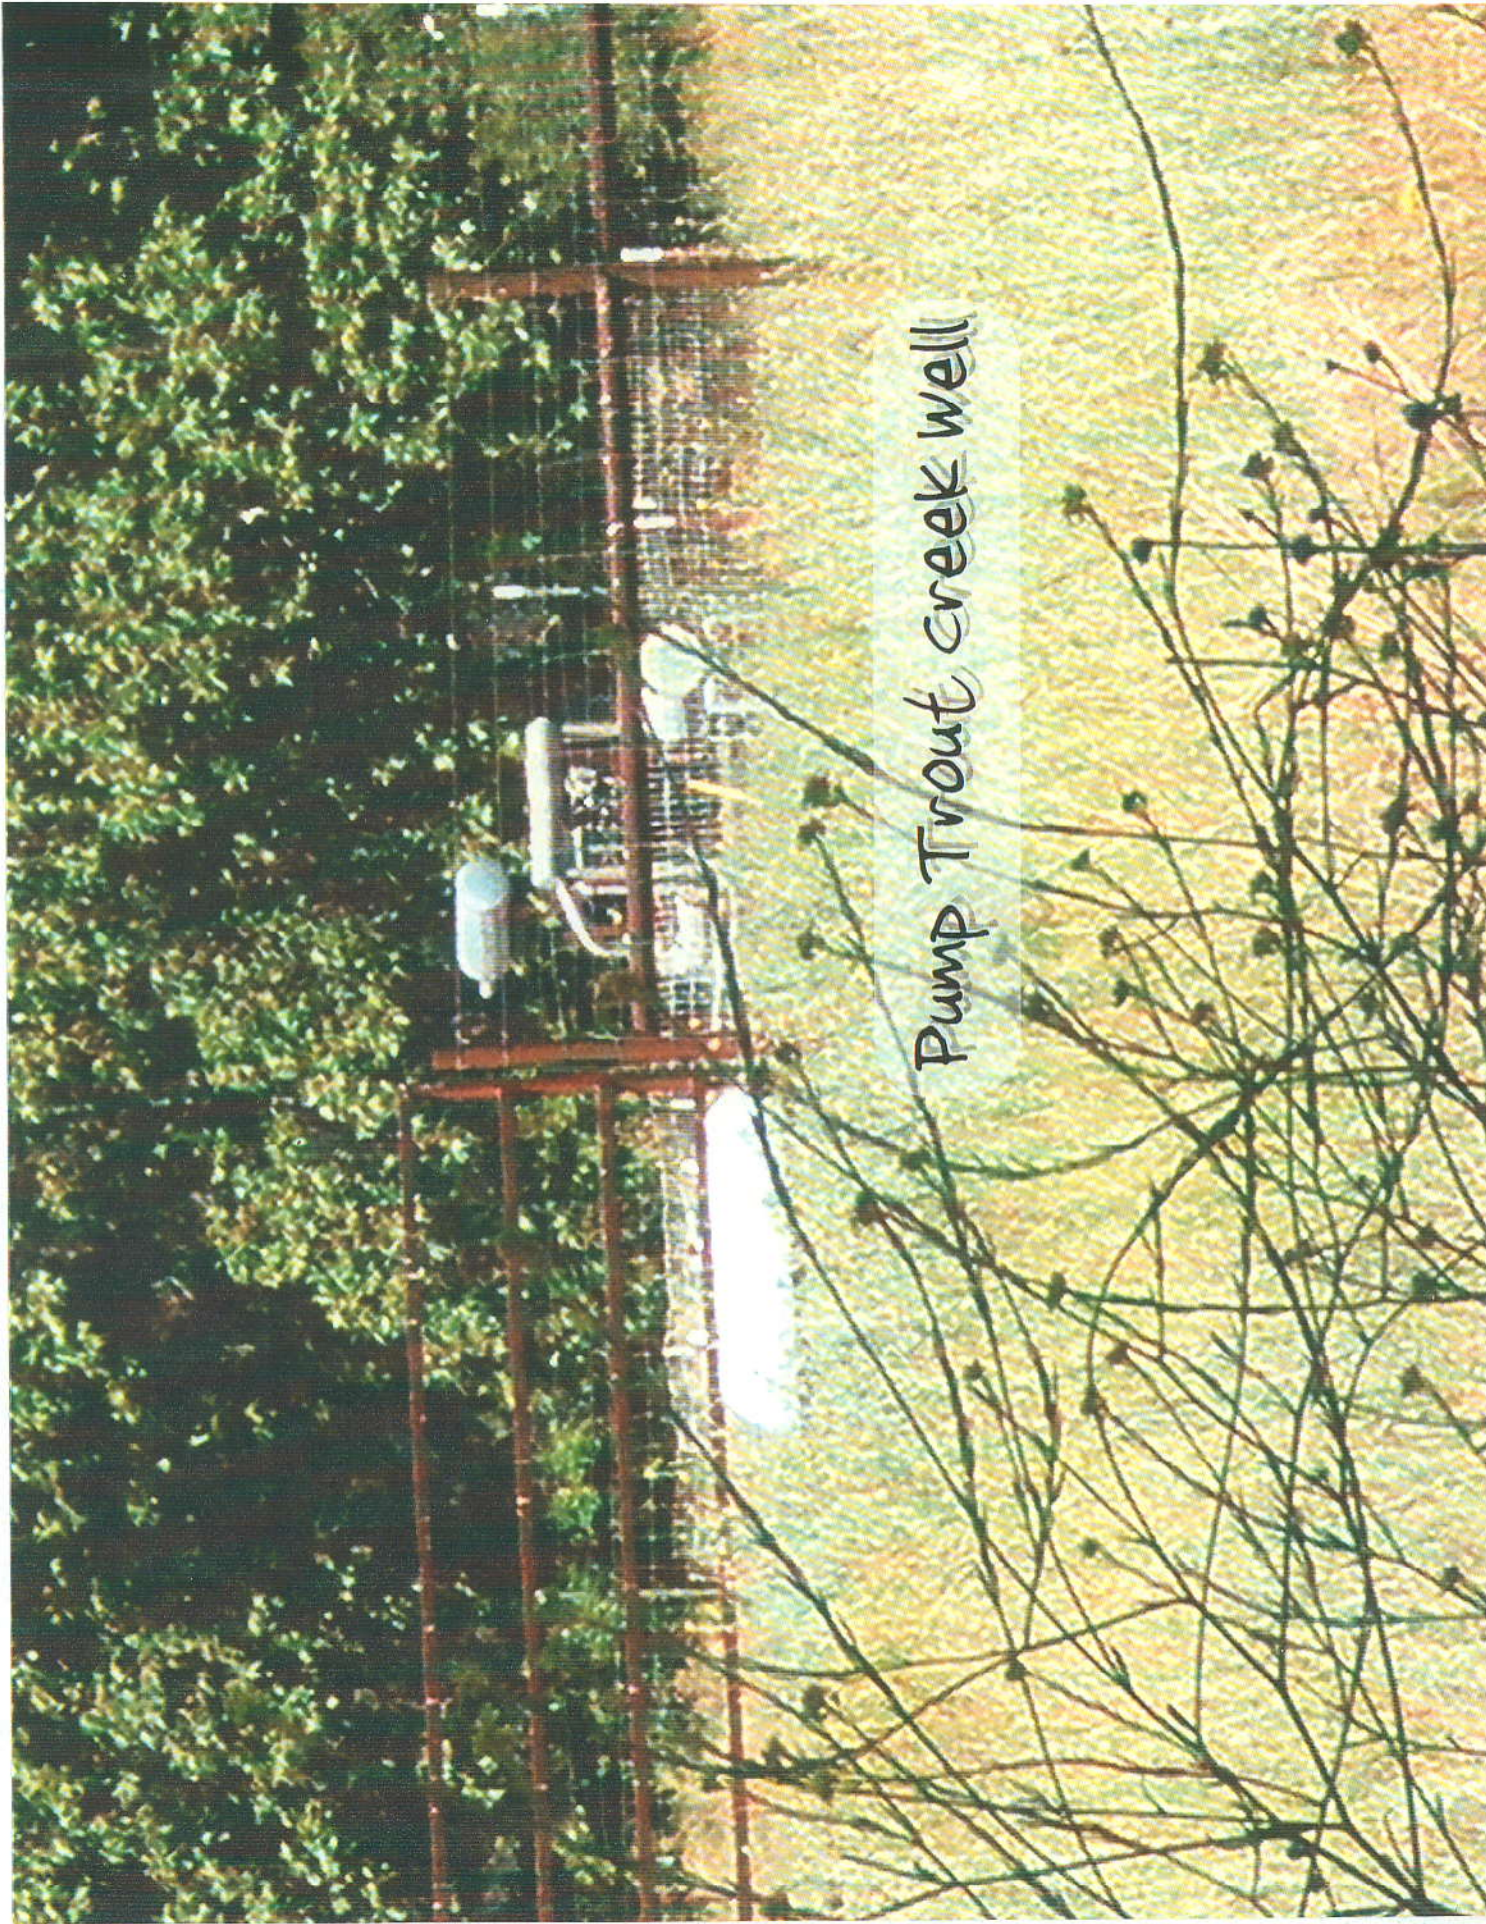
concrete Reservoir Next to Trout creek well And Pump  
Station
